CITIZEN SCIENTISTS IN ACTION

STRAITS POND MIDGE LARVA AND BATHYMETRIC SURVEY

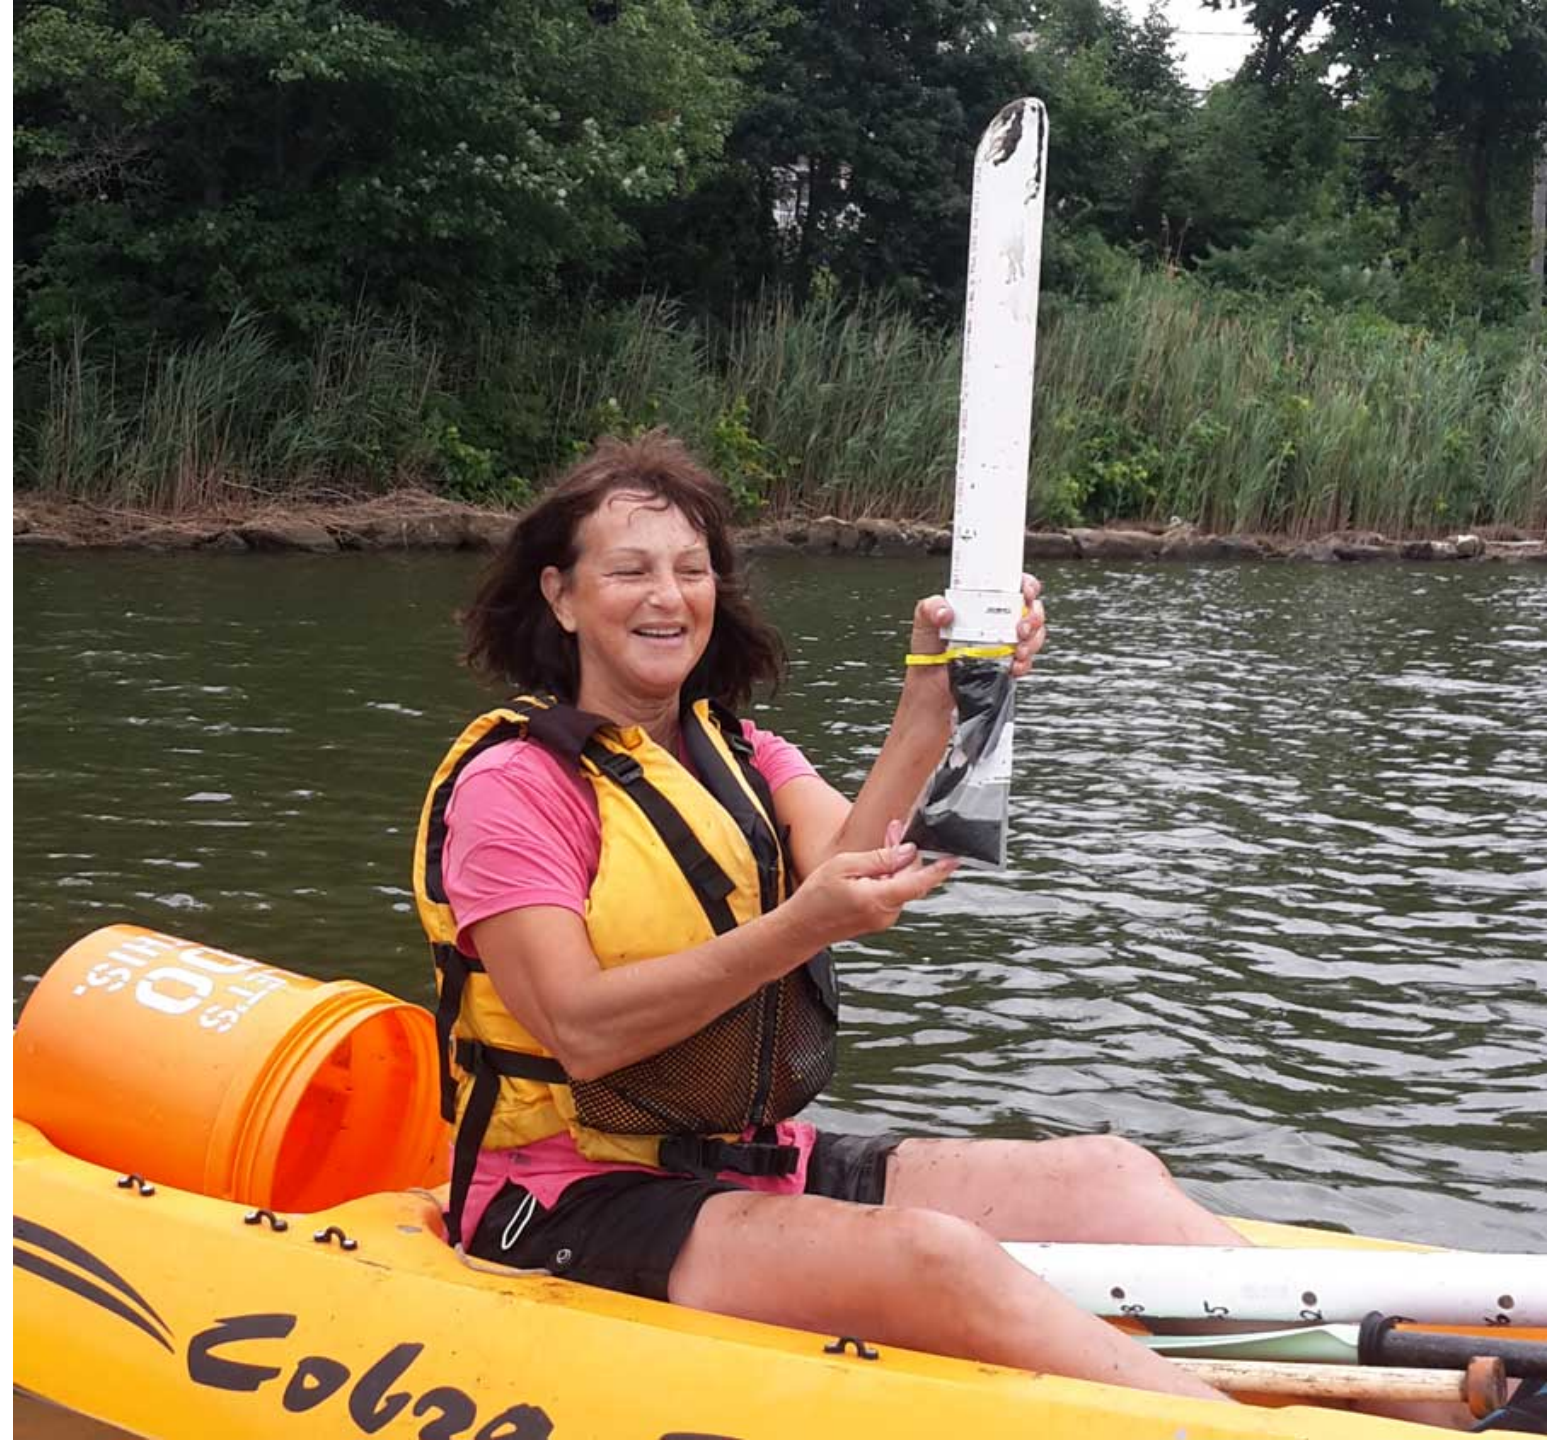
Taking a core is sloppy business

Each sample was a composite of three, two inch diameter cores, where only the top two inches was collected.

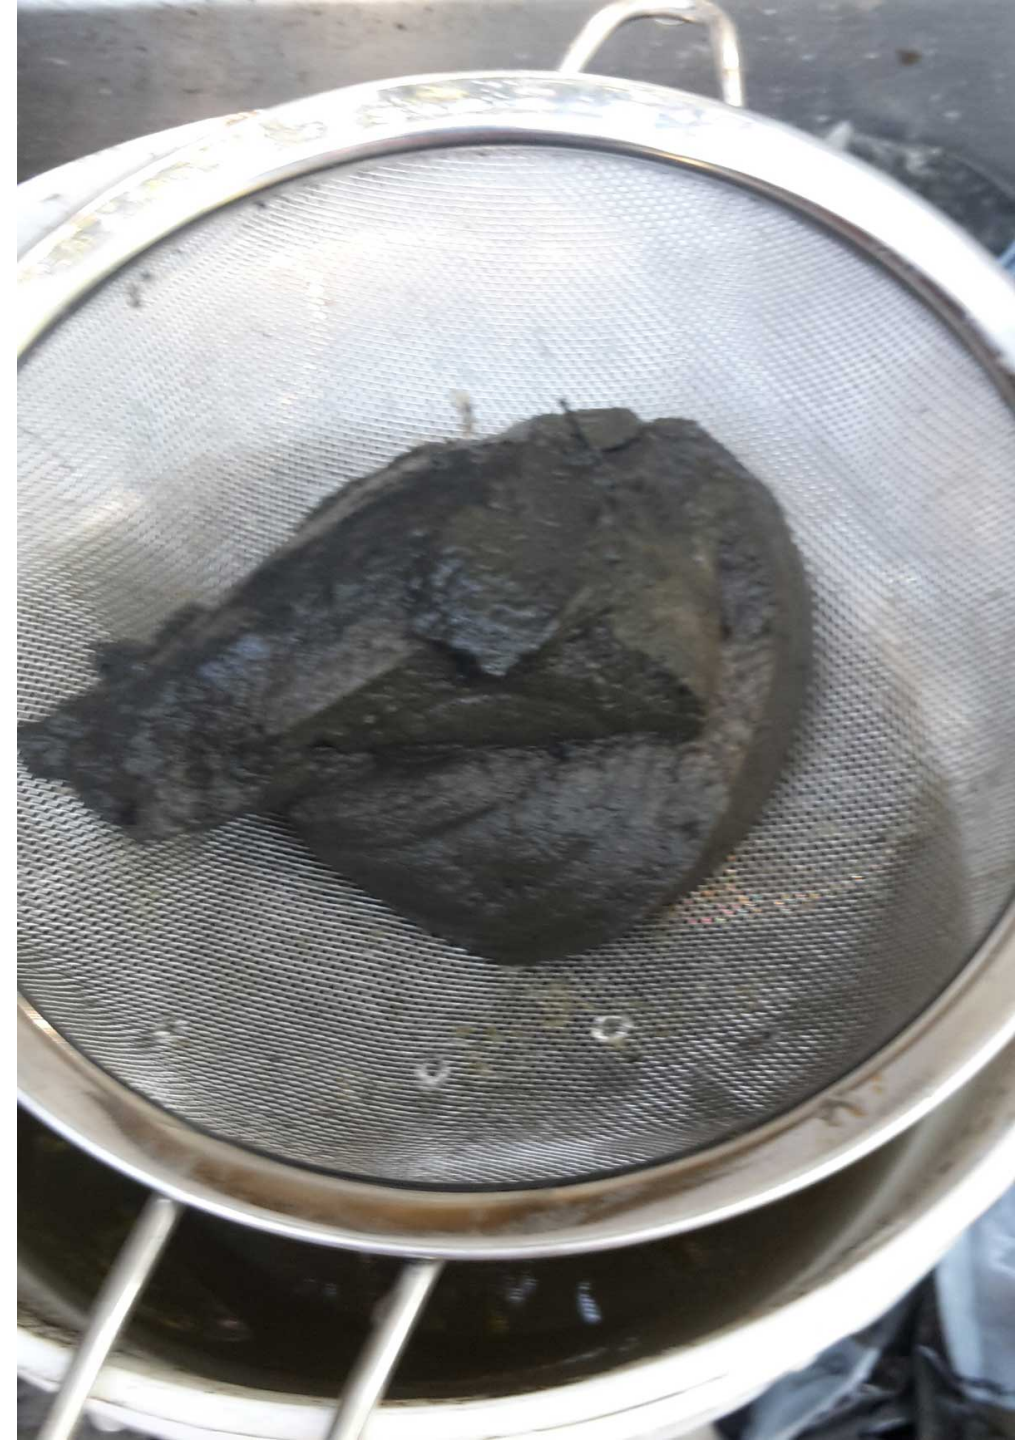
Processing core is a delicate task

Most of the samples consisted of decayed organic matter that blankets large areas of the bottom of the Pond.

Midge larva prefer to live in this type of sediment.

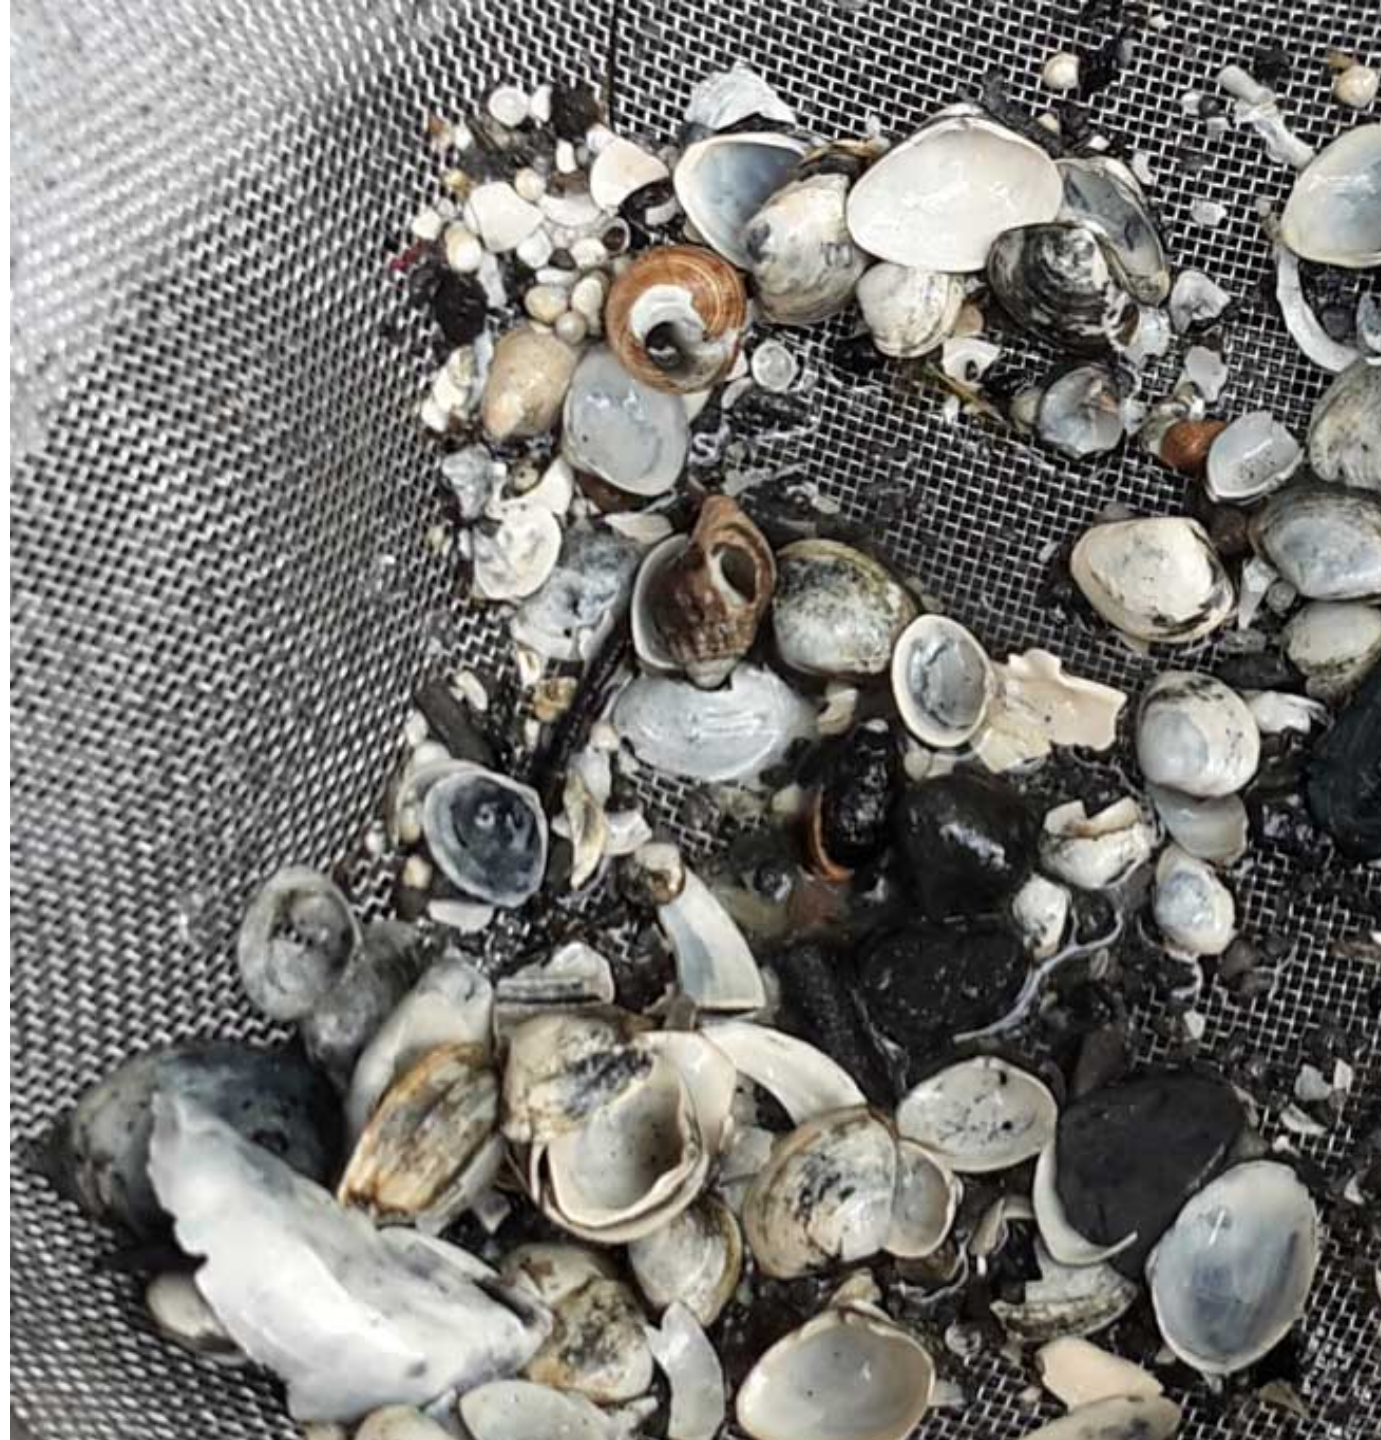
After a gentle rinse, what remains is inspected

**There is more to see than
midge larvae.**

**Clams, snails, and sea
worms are common.**

**Partially decayed reeds are
common in shallow
nearshore samples.**

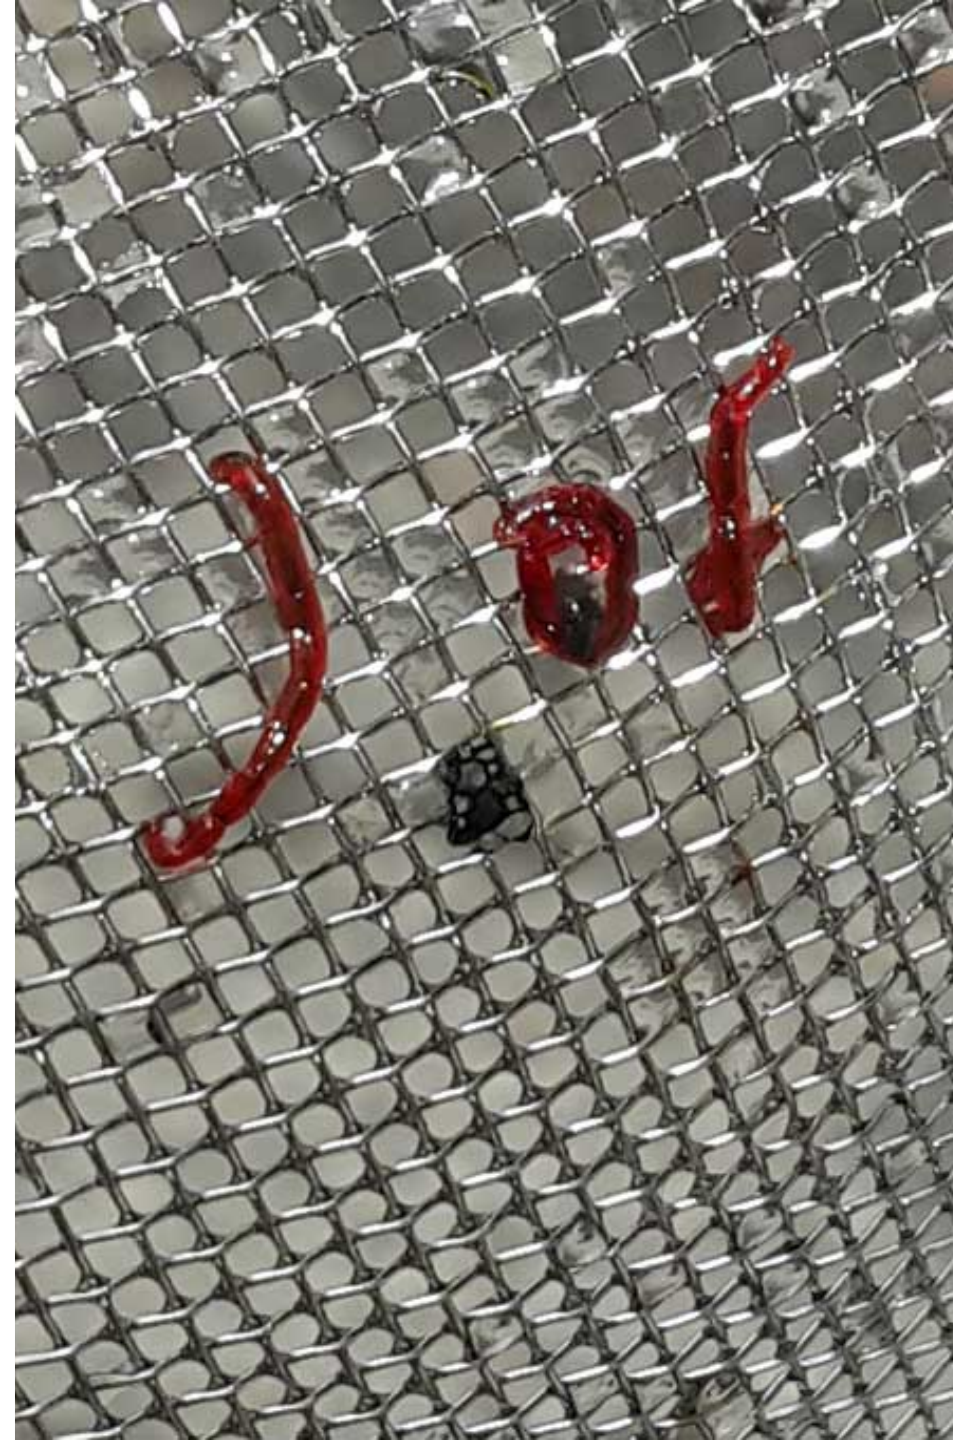
Some samples contained midge larvae

Midge larvae were found in samples that had indications of low oxygen.

The blood red color of midge larvae is hemoglobin, their means of storing oxygen to use when times get tough.

- All midge larvae were observed in reduced very fine-grained organic sediment.
- Midge larvae were never observed in core with oxidized degraded phragmites debris.
- Few midge larvae were observed in samples from the intertidal zone.
- Below depths of about one meter, no pattern of larvae presence by depth was observed.
- Midge larvae were frequently accompanied by juvenile softshell clams and snails of all sizes.
- Most samples with clams and snails did not contain midge larvae.
- Midge larvae ranged in length from 3 to 8mm.

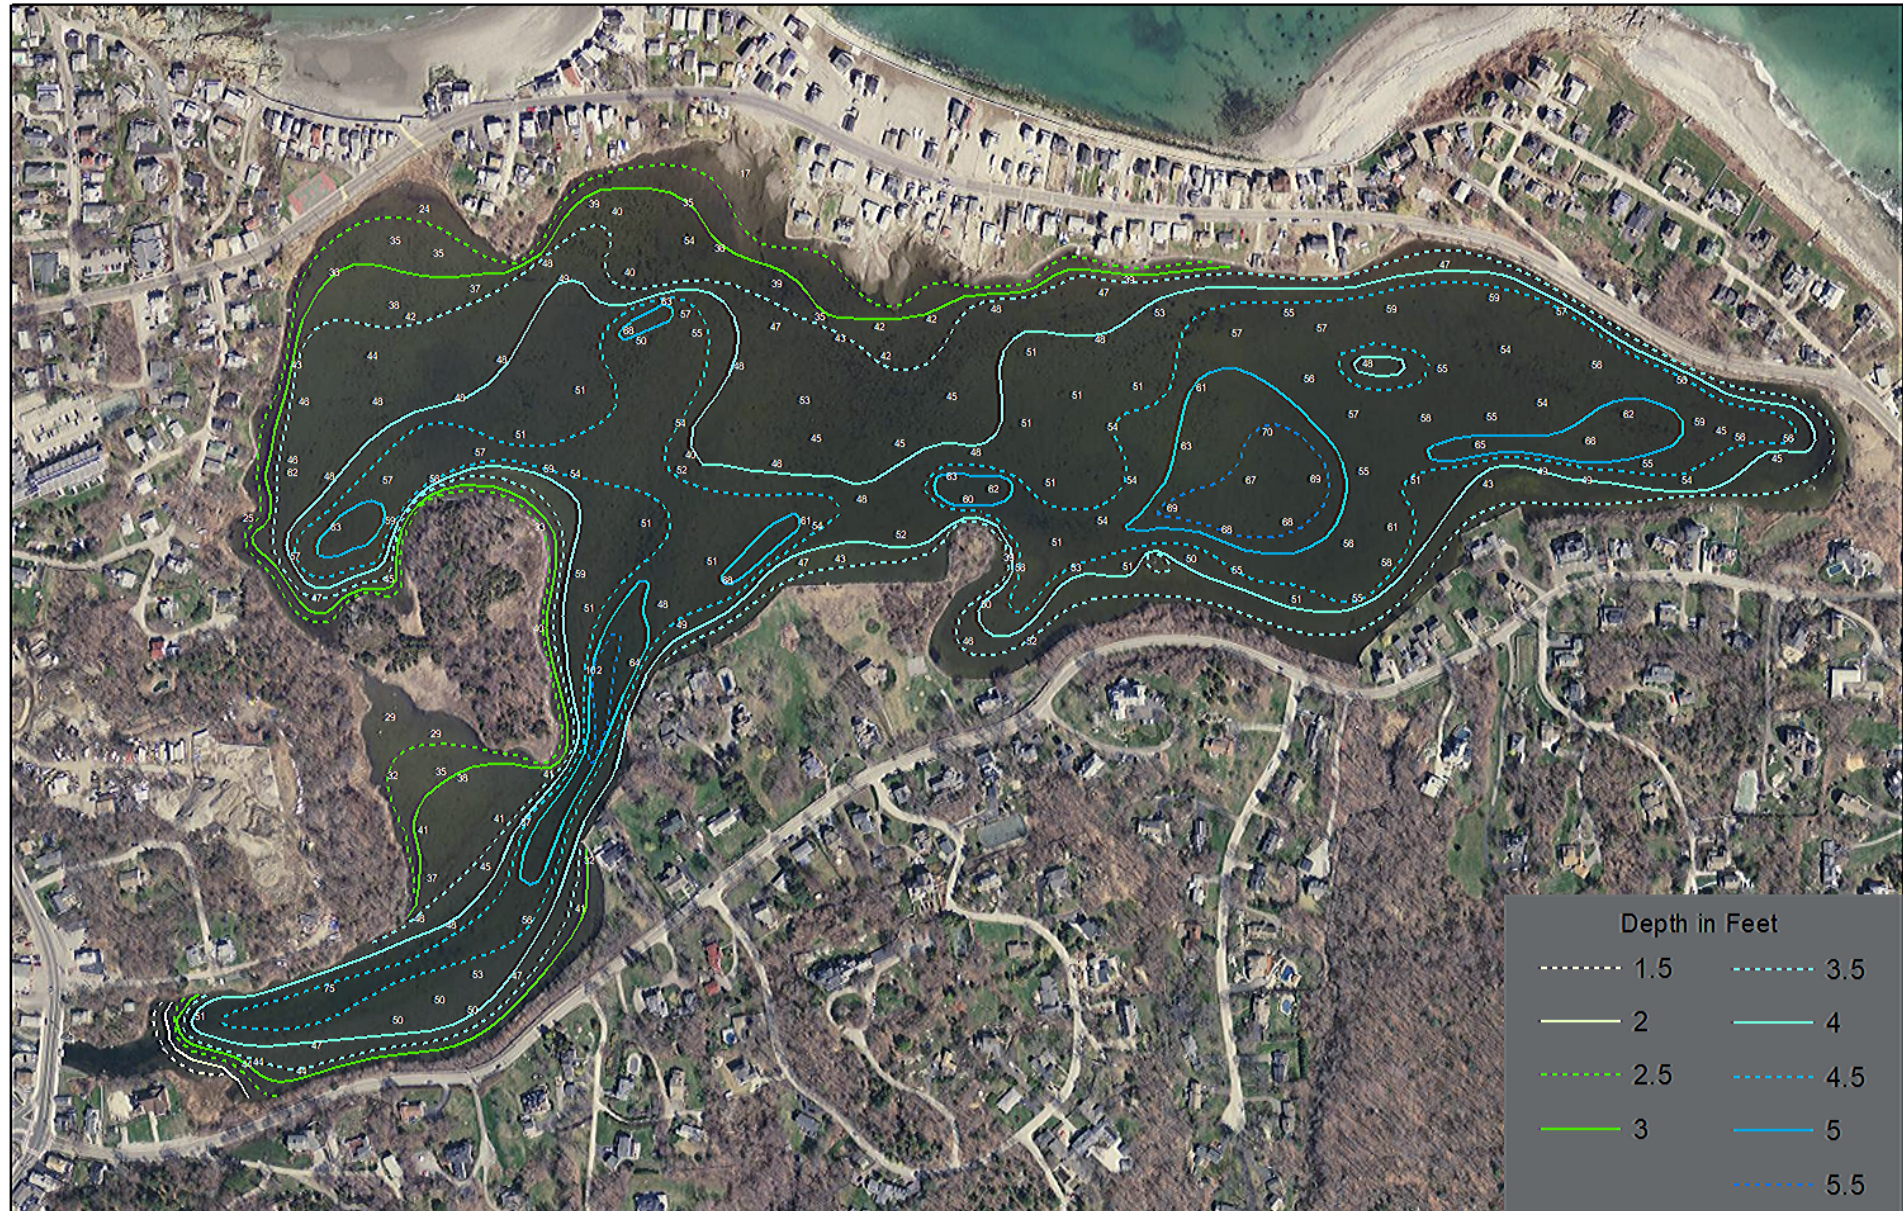
DEPTH AT 3FT WATERLEVEL

How deep is the Pond?

Based on depth measurements at 170 sites, corrected for the tide phase when taken, and an air photo taken when the Pond water was exceptionally clear we were able to make a new bathymetric map of the Pond.
